Breaking Mobile Bootloaders

Mobile Bootloaders

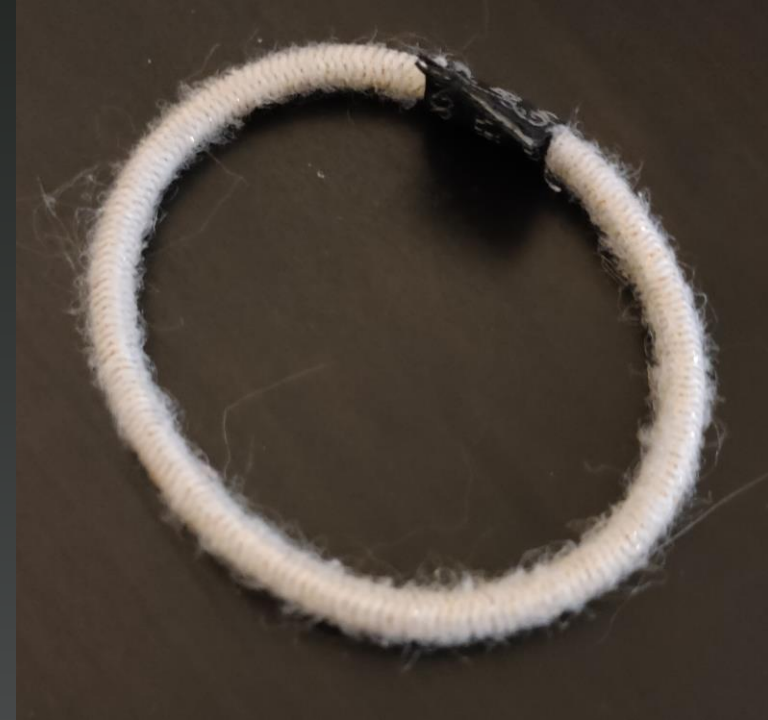
Once this was generated, it could potentially be modified to gain code execution

A hair tie was wrapped around the power and volume buttons to force a boot loop
